THE SCOPE OF THIS PROJECT IS TO REPLACE THE CORRODED SPRINKLER PIPING IN THE HEALTH SCIENCE BUILDING. THE PIPING WAS SCANNED UTILIZING ULTRASONIC TESTING DEVICES TO DETERMINE THE AMOUNT OF CORROSION IN VARIOUS SEGMENTS OF THE PIPING SYSTEM. THE SCAN RESULTS ARE INCLUDED ON THESE DRAWINGS FOR THE SECTIONS OF PIPING THAT WAS IDENTIFIED AS NEEDING TO BE REPLACED. SOME OF THE SCANS ARE OF THE SMALL DIAMETER PIPING AT THE ARM-OVERS TO THE SPRINKLER HEADS. THE SCOPE SHALL INCLUDE REPLACING ALL THE ARM-OVERS AND EXISTING SPRINKLER HEADS WITH NEW FLEXIBLE SPRINKLER HEADS.

1 FIRE PROTECTION PIPE REPLACEMENT INFORMATION

SCC-RE-BID HSB Fire Sprinkler Modifications
 NOT FOR CONSTRUCTION
 FOR PRICING ONLY

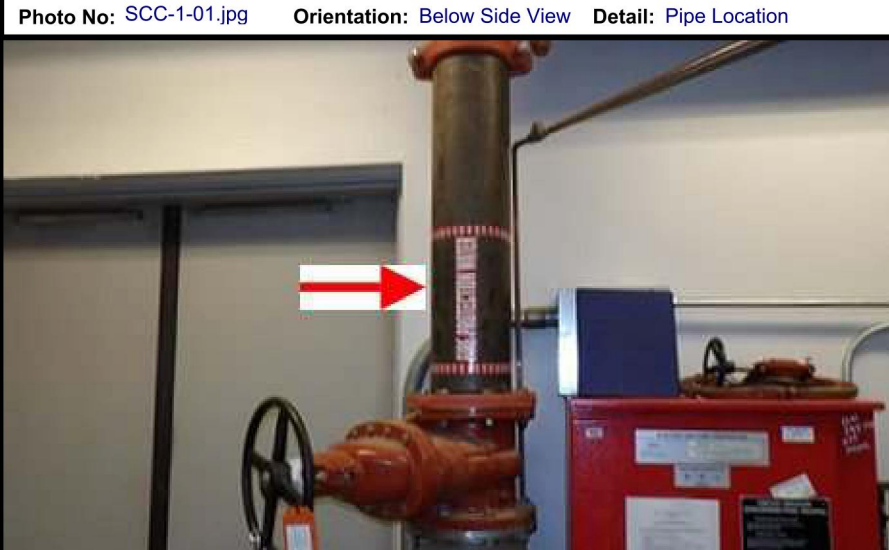
Test Location No: 1

Piping Technicalities
 Location - Health Science Building 1st Floor Fire Pump Room. Fire sprinkler main supply line, in the pump. Test points located 1-24 in. above main location valve.

Base Statistical Calculations
 Reported Wall Thickness: **0.189 in.**
 ASTM Wall Thickness: **0.189 in.**
 Barlow Calculated Minimum: **0.044 in.**
 Default Minimum Wall: **0.105 in.**
 Minimum Allowable Thickness: **0.095 in.**
 Minimum Value Based On: Default Value
 High To Low Range: 0.052 in.
 Proximity To Threads Or Groove Cut: Not Applicable
 Standard Deviation: 0.017
 Pitting Index: 19.66 High Pitting Activity

Average Based Scenario
 Average Wall Thickness: **0.158 in.**
 Average Pipe Loss: 0.030 in.
 Average Corrosion Rate: 2.7 mpy
 Percent of Allowable Loss: 36.0 %
 Average Pipe Life: 40.7 years
 Estimated Retirement: **April 2054**

Minimum Based Scenario
 Minimum Wall Thickness: **0.127 in.**
 Maximum Pipe Loss: 0.061 in.
 Maximum Corrosion Rate: 2.7 mpy
 Percent of Allowable Loss: 73.5 %
 Minimum Pipe Life: 8.3 years
 Estimated Retirement: **November 2031**

Theoretical Based Scenario
 Theoretically Lowest Thickness: **0.116 in.**
 Theoretical Pipe Loss: 0.072 in.
 Theoretical Corrosion Rate: 3.1 mpy
 Percent of Allowable Loss: 86.4 %
 Lowest Theoretical Life: 3.6 years
 Estimated Retirement: **March 2027**

Testing Indicators: Pipe is Approaching Retirement

Overall Assessment: We measure higher than normal corrosion and pitting activity at this example, which is not unusual for pump related fire pipe having more flow and oxygen content. We estimate some service life available but still show the pipe approaching retirement.

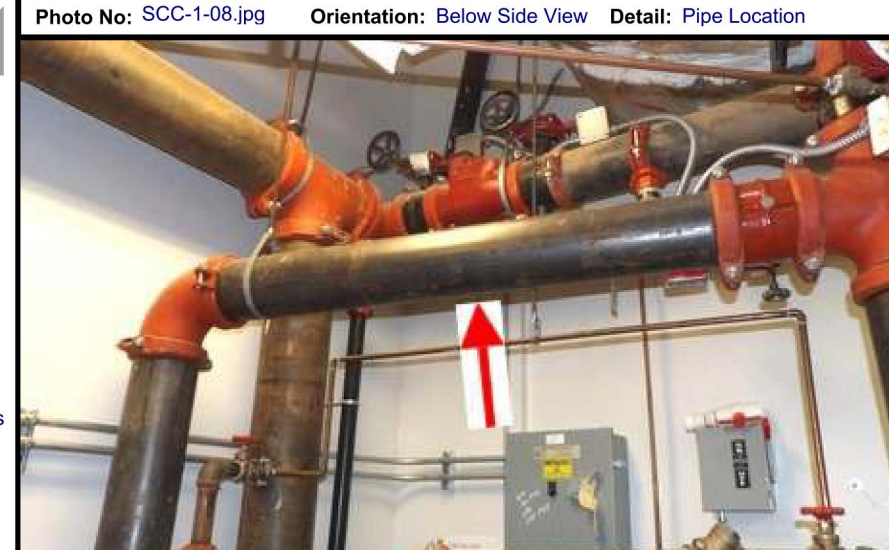
Test Location No: 4

Piping Technicalities
 Location - Health Science Building 1st Floor Fire Pump Room. Fire sprinkler FDC connection. Test points located between valve and elbow.

Average Based Scenario
 Average Wall Thickness: **0.111 in.**
 Average Pipe Loss: 0.022 in.
 Average Corrosion Rate: 1.9 mpy
 Percent of Allowable Loss: 55.6 %
 Average Pipe Life: 18.4 years
 Estimated Retirement: **December 2041**

Minimum Based Scenario
 Minimum Wall Thickness: **0.093 in.**
 Maximum Pipe Loss: 0.041 in.
 Maximum Corrosion Rate: 1.9 mpy
 Percent of Allowable Loss: 100.0 %
 Minimum Pipe Life: 0.0 years
 Estimated Retirement: **August 2023**

Theoretical Based Scenario
 Theoretically Lowest Thickness: **0.088 in.**
 Theoretical Pipe Loss: 0.040 in.
 Theoretical Corrosion Rate: 2.0 mpy
 Percent of Allowable Loss: 100.0 %
 Lowest Theoretical Life: 0.0 years
 Estimated Retirement: **August 2023**

Testing Indicators: Pipe Replacement Indicated

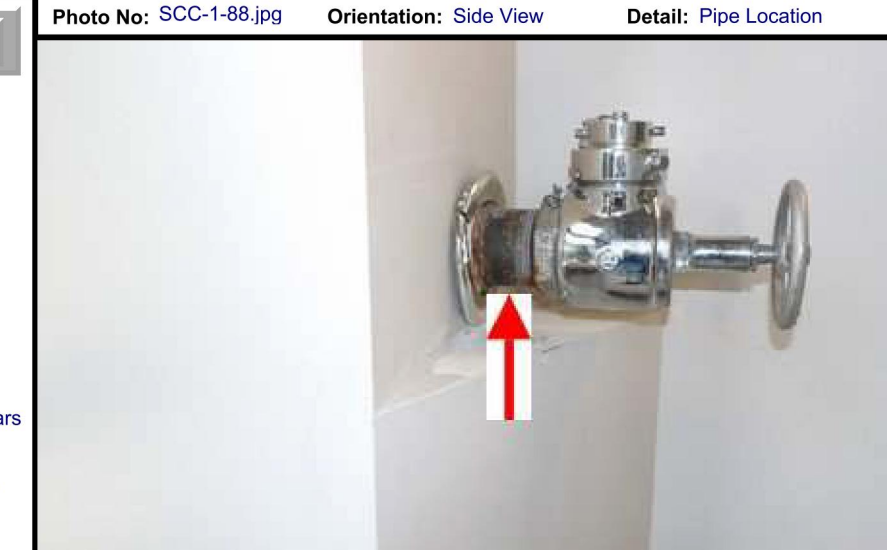
Piping Technicalities
 Location - Health Science Building 1st Floor Fire Pump Room. Fire sprinkler FDC connection. Test points located between wall and valve.

Average Based Scenario
 Average Wall Thickness: **0.181 in.**
 Average Pipe Loss: 0.022 in.
 Average Corrosion Rate: 1.9 mpy
 Percent of Allowable Loss: 35.2 %
 Average Pipe Life: 42.3 years
 Estimated Retirement: **November 2055**

Minimum Based Scenario
 Minimum Wall Thickness: **0.172 in.**
 Maximum Pipe Loss: 0.031 in.
 Maximum Corrosion Rate: 1.4 mpy
 Percent of Allowable Loss: 50.5 %
 Minimum Pipe Life: 22.5 years
 Estimated Retirement: **January 2046**

Theoretical Based Scenario
 Theoretically Lowest Thickness: **0.166 in.**
 Theoretical Pipe Loss: 0.037 in.
 Theoretical Corrosion Rate: 1.6 mpy
 Percent of Allowable Loss: 60.2 %
 Lowest Theoretical Life: 15.1 years
 Estimated Retirement: **September 2038**

Testing Indicators: Pipe Replacement is Mandatory

Overall Assessment: Testing at this smaller threaded hose connection identifies schedule 40 pipe. We observed signs of water damage to the wall below, and rust at the threads which suggests that some installation deficiency has resulted in a thread leak. Based on our wall thickness readings alone, very long service life remains.

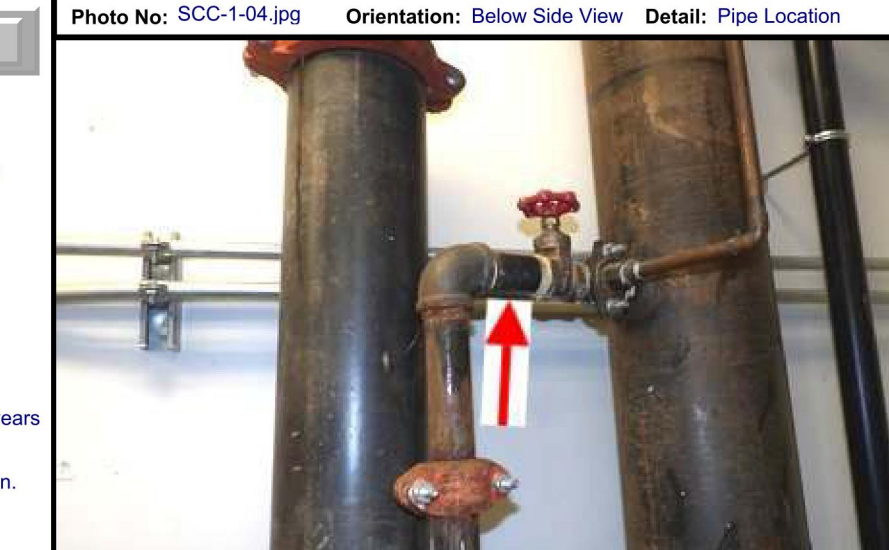
Piping Technicalities
 Location - Health Science Building 1st Floor Fire Pump Room. Fire sprinkler jockey pump. Test points located between valve and elbow.

Average Based Scenario
 Average Wall Thickness: **0.114 in.**
 Average Pipe Loss: 0.028 in.
 Average Corrosion Rate: 1.7 mpy
 Percent of Allowable Loss: 57.2 %
 Average Pipe Life: 17.2 years
 Estimated Retirement: **September 2040**

Minimum Based Scenario
 Minimum Wall Thickness: **0.102 in.**
 Maximum Pipe Loss: 0.038 in.
 Maximum Corrosion Rate: 1.7 mpy
 Percent of Allowable Loss: 84.4 %
 Minimum Pipe Life: 4.2 years
 Estimated Retirement: **October 2027**

Theoretical Based Scenario
 Theoretically Lowest Thickness: **0.098 in.**
 Theoretical Pipe Loss: 0.042 in.
 Theoretical Corrosion Rate: 1.8 mpy
 Percent of Allowable Loss: 92.6 %
 Lowest Theoretical Life: 1.8 years
 Estimated Retirement: **June 2025**

Testing Indicators: Pipe Replacement is Mandatory

Overall Assessment: Testing at this jockey pump line produces still good results. A higher movement of water often deteriorates this smaller threaded pipe ahead of all other examples. A thread leak at the joint defines its replacement as mandatory.

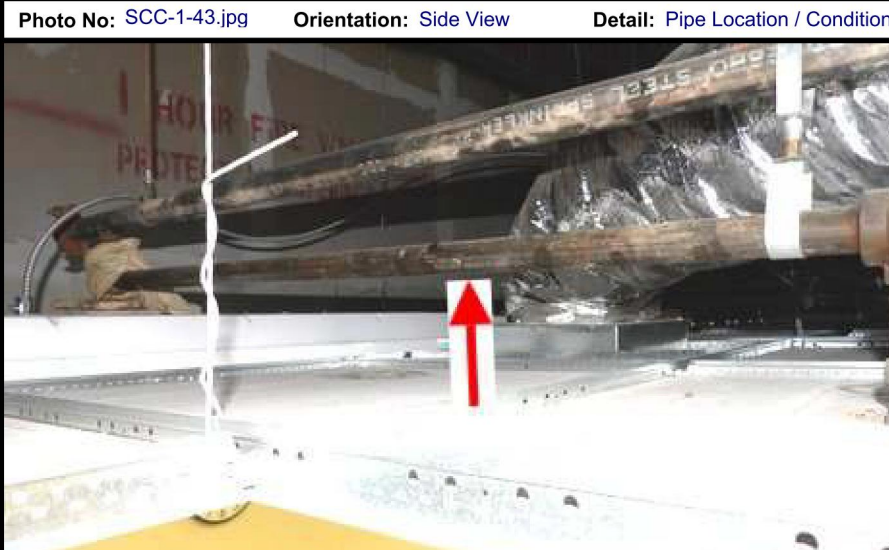
Piping Technicalities
 Location - Health Science Building 1st Floor Community Room 115. Fire sprinkler branch line to sprinkler head. Test points located between elbows.

Average Based Scenario
 Average Wall Thickness: **0.117 in.**
 Average Pipe Loss: 0.016 in.
 Average Corrosion Rate: 0.7 mpy
 Percent of Allowable Loss: 41.7 %
 Average Pipe Life: 32.1 years
 Estimated Retirement: **September 2055**

Minimum Based Scenario
 Minimum Wall Thickness: **0.112 in.**
 Maximum Pipe Loss: 0.021 in.
 Maximum Corrosion Rate: 0.9 mpy
 Percent of Allowable Loss: 55.3 %
 Minimum Pipe Life: 18.6 years
 Estimated Retirement: **March 2048**

Theoretical Based Scenario
 Theoretically Lowest Thickness: **0.109 in.**
 Theoretical Pipe Loss: 0.024 in.
 Theoretical Corrosion Rate: 1.0 mpy
 Percent of Allowable Loss: 52.1 %
 Lowest Theoretical Life: 14.0 years
 Estimated Retirement: **August 2037**

Testing Indicators: Pipe Replacement is Mandatory

Overall Assessment: Testing at this portion of the pipe length produces good results in terms of remaining wall thickness, but also identifies a nearby leak at a threaded connection. A thread leak at this branch line defines pipe replacement as mandatory.

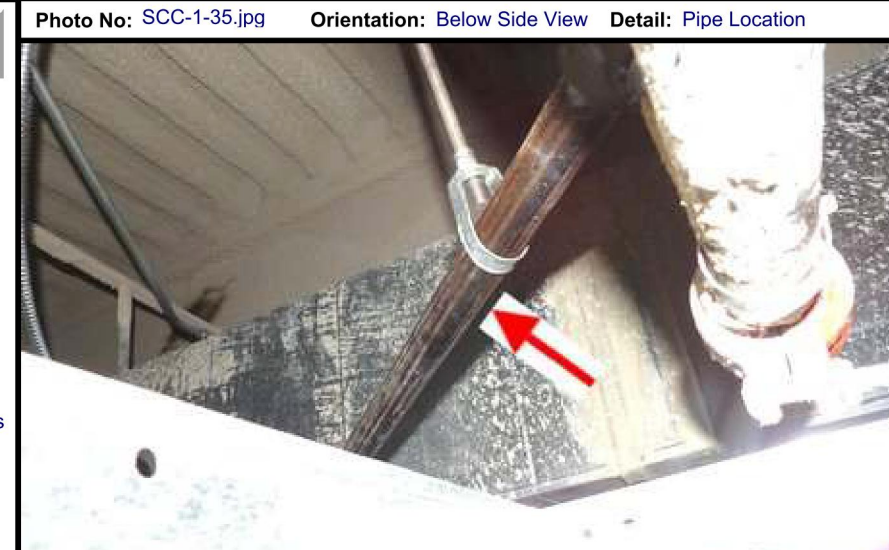
Piping Technicalities
 Location - Health Science Building 1st Floor Community Room 115. Fire sprinkler branch line to sprinkler head, in front of storage room 114. Test points located between elbows, 1st 8 measurements at random, last 3 at weld seam.

Average Based Scenario
 Average Wall Thickness: **0.111 in.**
 Average Pipe Loss: 0.022 in.
 Average Corrosion Rate: 1.0 mpy
 Percent of Allowable Loss: 50.0 %
 Average Pipe Life: 18.0 years
 Estimated Retirement: **July 2039**

Minimum Based Scenario
 Minimum Wall Thickness: **0.095 in.**
 Maximum Pipe Loss: 0.039 in.
 Maximum Corrosion Rate: 1.7 mpy
 Percent of Allowable Loss: 100.0 %
 Minimum Pipe Life: 0.0 years
 Estimated Retirement: **August 2023**

Theoretical Based Scenario
 Theoretically Lowest Thickness: **0.088 in.**
 Theoretical Pipe Loss: 0.045 in.
 Theoretical Corrosion Rate: 2.0 mpy
 Percent of Allowable Loss: 20.0 %
 Lowest Theoretical Life: 0.0 years
 Estimated Retirement: **August 2023**

Testing Indicators: Pipe Replacement Indicated

Overall Assessment: Low wall thickness measurements at this pipe section were specifically identified along the ERW weld seam. Wall loss may be due to an incomplete weld seam, or higher localized corrosion at the seam itself. Low thickness measurements at the weld seam suggest that no further reliable service life is available. Pipe wall exists 22 mils from the thread cut.

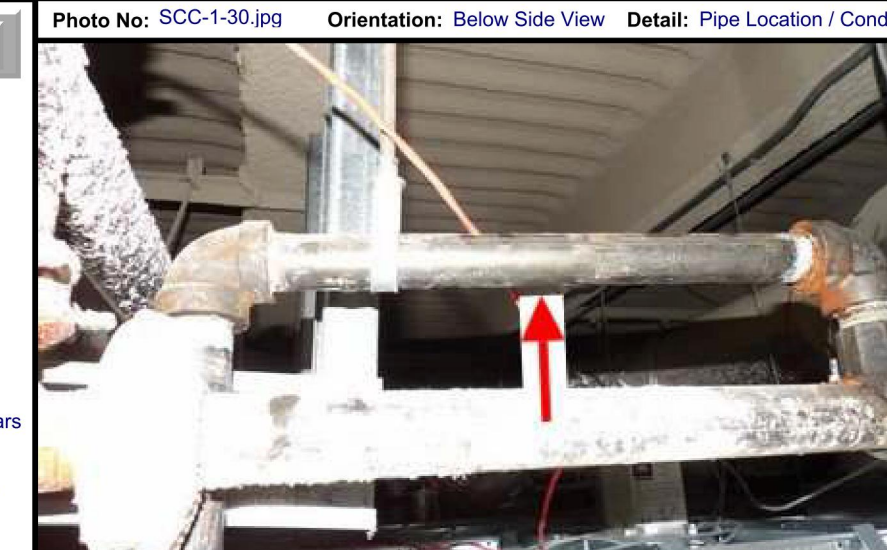
Piping Technicalities
 Location - Health Science Building 1st Floor Community Room 115. Fire sprinkler branch line to sprinkler head, in seating area. Test points located between elbows.

Average Based Scenario
 Average Wall Thickness: **0.116 in.**
 Average Pipe Loss: 0.017 in.
 Average Corrosion Rate: 0.7 mpy
 Percent of Allowable Loss: 43.9 %
 Average Pipe Life: 29.4 years
 Estimated Retirement: **December 2058**

Minimum Based Scenario
 Minimum Wall Thickness: **0.114 in.**
 Maximum Pipe Loss: 0.019 in.
 Maximum Corrosion Rate: 0.8 mpy
 Percent of Allowable Loss: 52.0 %
 Minimum Pipe Life: 23.0 years
 Estimated Retirement: **July 2046**

Theoretical Based Scenario
 Theoretically Lowest Thickness: **0.114 in.**
 Theoretical Pipe Loss: 0.019 in.
 Theoretical Corrosion Rate: 0.8 mpy
 Percent of Allowable Loss: 50.9 %
 Lowest Theoretical Life: 22.1 years
 Estimated Retirement: **September 2045**

Testing Indicators: Pipe Replacement is Mandatory

Overall Assessment: Based on our wall thickness readings alone, we still estimate long service life remaining. However, a thread leak at this pipe section defines its replacement as mandatory.

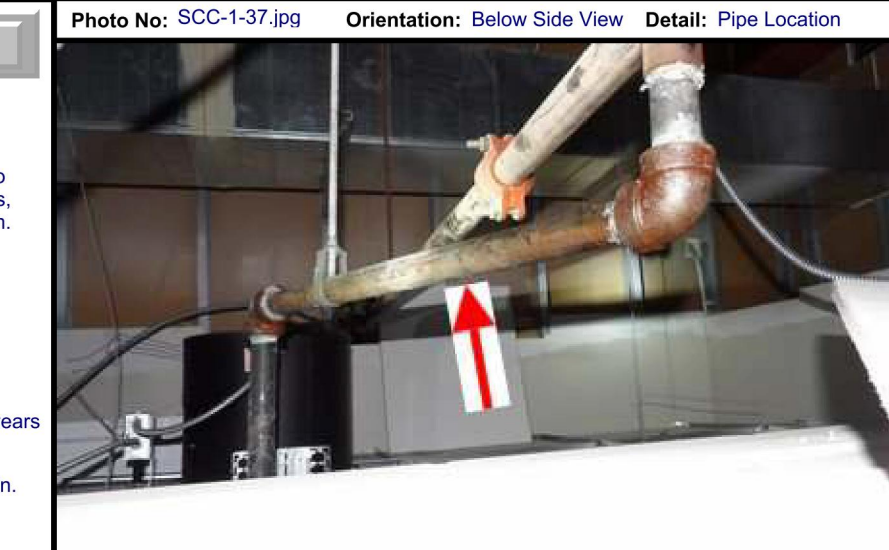
Piping Technicalities
 Location - Health Science Building 1st Floor Community Room 117. Fire sprinkler branch line to sprinkler head. Test points located between elbows, 1st 9 measurements at random, last 3 at weld seam.

Average Based Scenario
 Average Wall Thickness: **0.112 in.**
 Average Pipe Loss: 0.021 in.
 Average Corrosion Rate: 0.9 mpy
 Percent of Allowable Loss: 54.2 %
 Average Pipe Life: 19.4 years
 Estimated Retirement: **January 2043**

Minimum Based Scenario
 Minimum Wall Thickness: **0.098 in.**
 Maximum Pipe Loss: 0.035 in.
 Maximum Corrosion Rate: 1.5 mpy
 Percent of Allowable Loss: 92.1 %
 Minimum Pipe Life: 2.0 years
 Estimated Retirement: **July 2025**

Theoretical Based Scenario
 Theoretically Lowest Thickness: **0.094 in.**
 Theoretical Pipe Loss: 0.039 in.
 Theoretical Corrosion Rate: 1.7 mpy
 Percent of Allowable Loss: 100.0 %
 Lowest Theoretical Life: 0.0 years
 Estimated Retirement: **August 2023**

Overall Assessment: Testing at this location again identified much lower wall thickness along the ERW weld seam. Wall loss may be due to an incomplete weld seam, or higher localized corrosion at the seam itself. We can estimate that limited and less reliable service life remains. Pipe wall exists 25 mils from the thread cut.

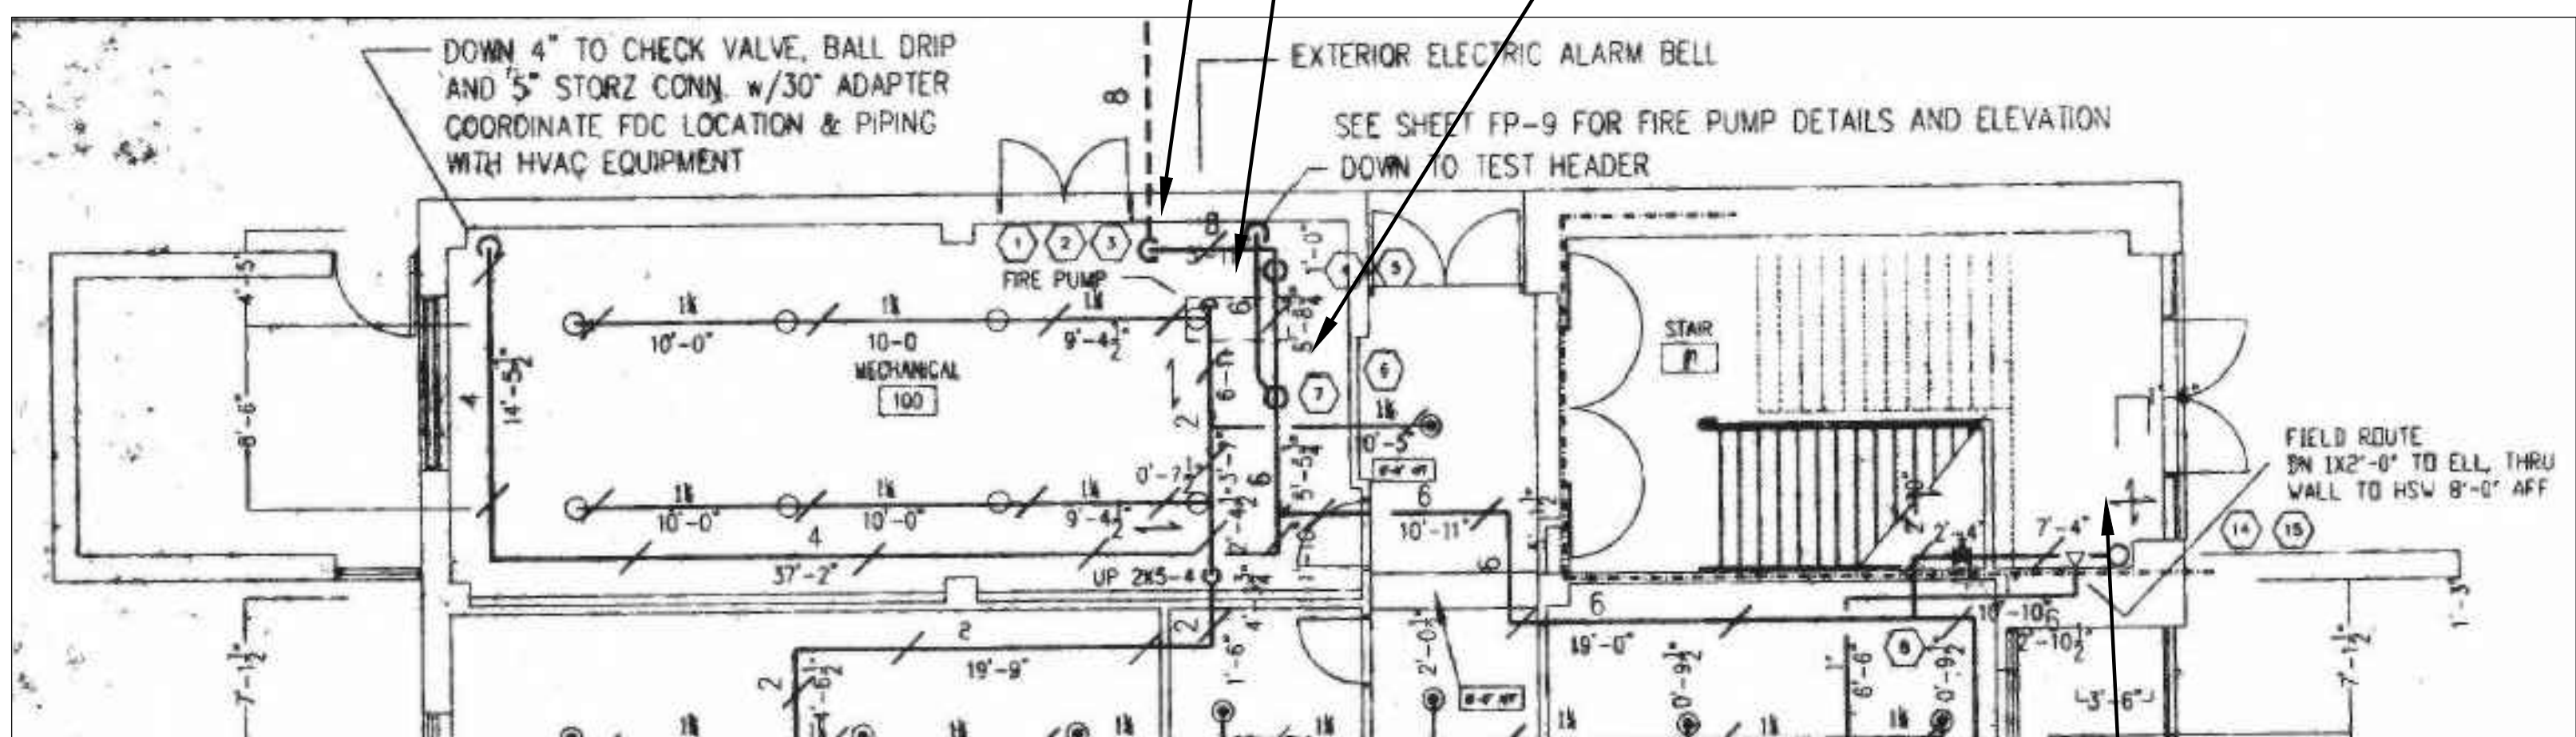
1 FIRE PROTECTION PIPE REPLACEMENT INFORMATION
NTS
1/8" = 1'-0"

ENLARGED PUMP ROOM - NTS

NUMBERS CORRESPONDS TO LOCATIONS IDENTIFIED ON DWGS FP1 AND FP2
